Slater Creek Stormwater Assessment and Action Plan

Monroe County Department of Environmental Services

Prepared by:
Monroe County Department of Environmental Services
September 30, 2015

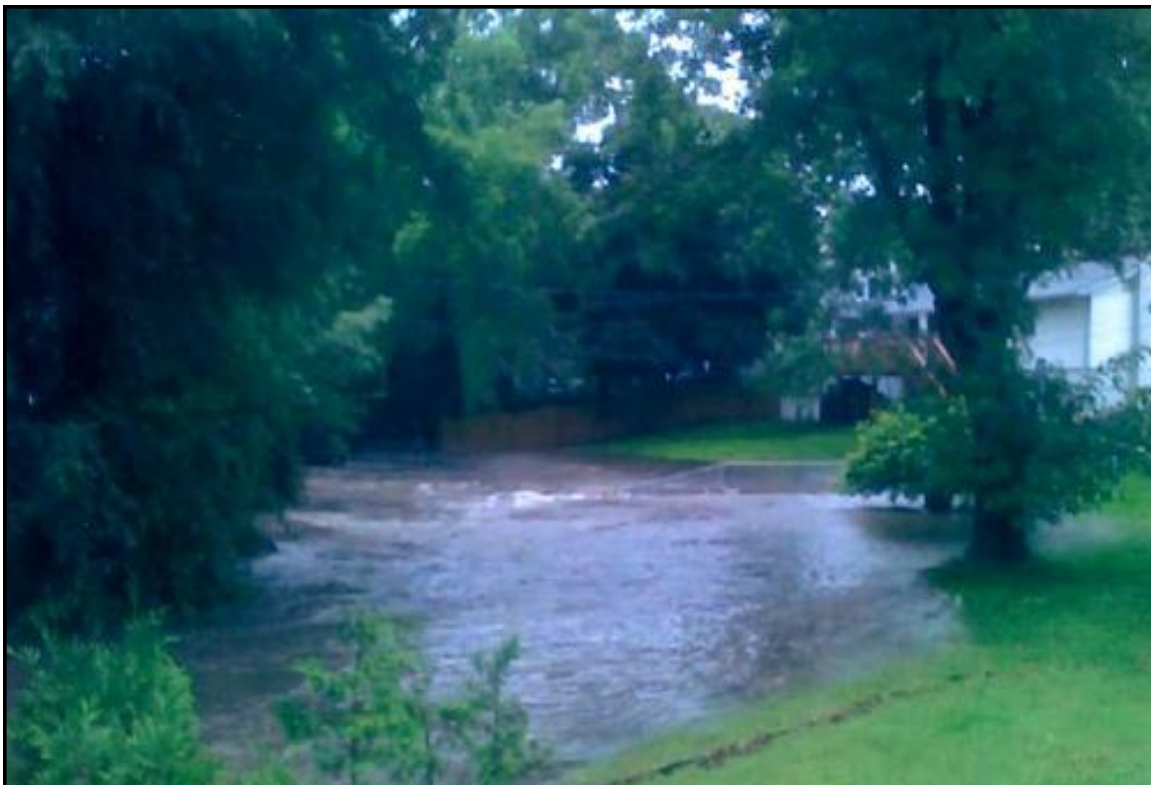
Figure 9 Fleming Creek Near Ripplewood Drive, 2008 flooding

In 2011 the Town of Greece studied the drainage issues at the confluence of Veness Creek and Fleming Creek (Erdman Anthony 2011). The area was prone to frequent flash flooding, resulting in nuisance and frequent yard repair to residents living along the stream corridor as shown in Figure 9. The goal of the study was to identify problems in the stream corridor and to decrease the frequency of flooding. Preliminary recommendations were to perform maintenance, remove obstructions, minimize debris potential, improve access, increase channel capacity, and improve performance of culverts. Although there are no specific water quality improvement measures proposed in the study, there will be some benefit to water quality from stream bank repair and flow attenuation measures.

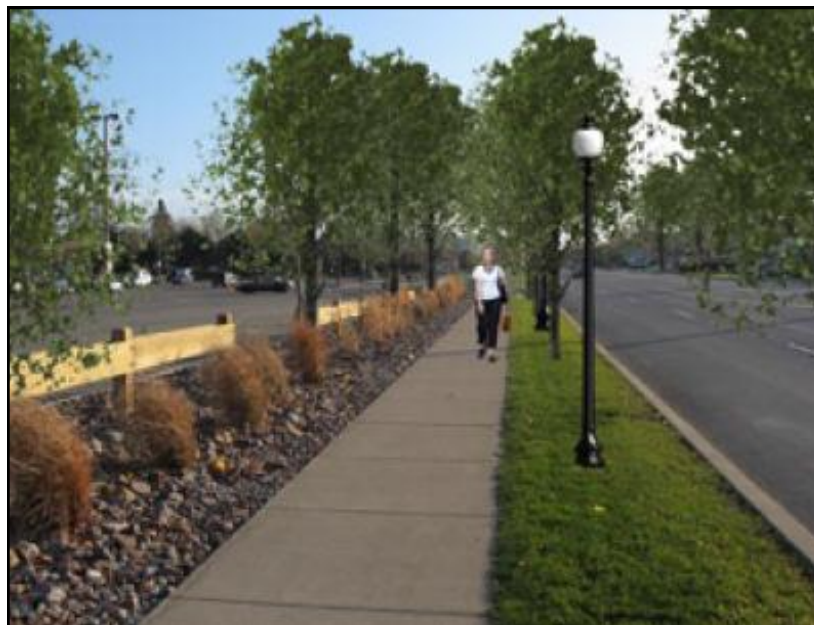
Figure 12 Dewey Ave Corridor Proposed Streetscape Enhancements

While the study and recommendations were not directed at stormwater, there will certainly be a net benefit to stormwater as the plan gets implemented. The proposed impervious cover reduction and open space enhancement will serve to reduce stormwater runoff and improve water quality. Figure 12 shows an example of proposed streetscape enhancements near Britton Road. Figure 13 demonstrates how redevelopment within a watershed can include improvements to water quality. The figure shows Northgate Plaza, a large multi acre parcel built well before current stormwater standards. The second photo shows the redevelopment of the plaza in 2012 that includes green infrastructure such as bioretention and swales as well as impervious cover reduction. As redevelopment occurs along Dewey Avenue we will see more of these kinds of features and the resultant benefit to water quality in Slater Creek.

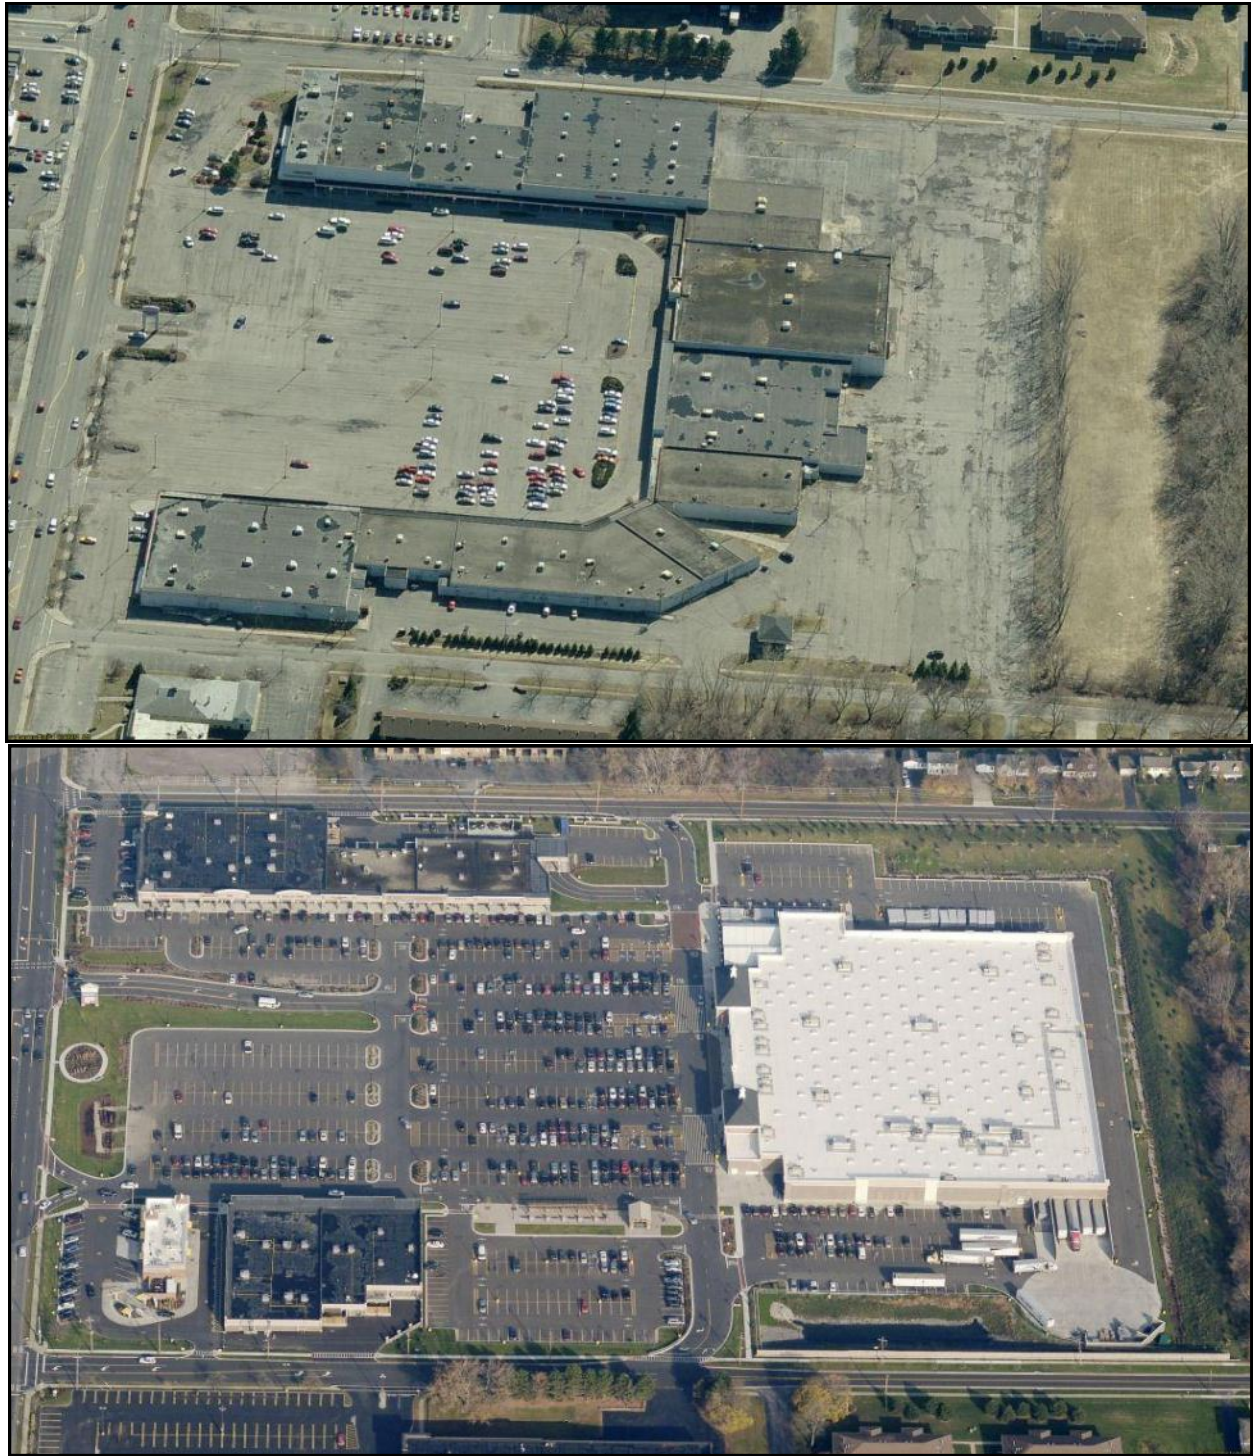
Figure 13 Northgate Plaza in 2009 (above) and 2012 (below) Showing impervious area reduction and increased green space
